**REPORT
GEOTECHNICAL STUDY
Replacement of Failed Retaining Wall at
5712 Country Club Drive
Oakland, California**

March 29, 2002

GEOTECNIA
Consulting Geotechnical Engineers
1624 Armstrong Court
Concord, California 94521
(925) 686-6556

Project Number: 020201

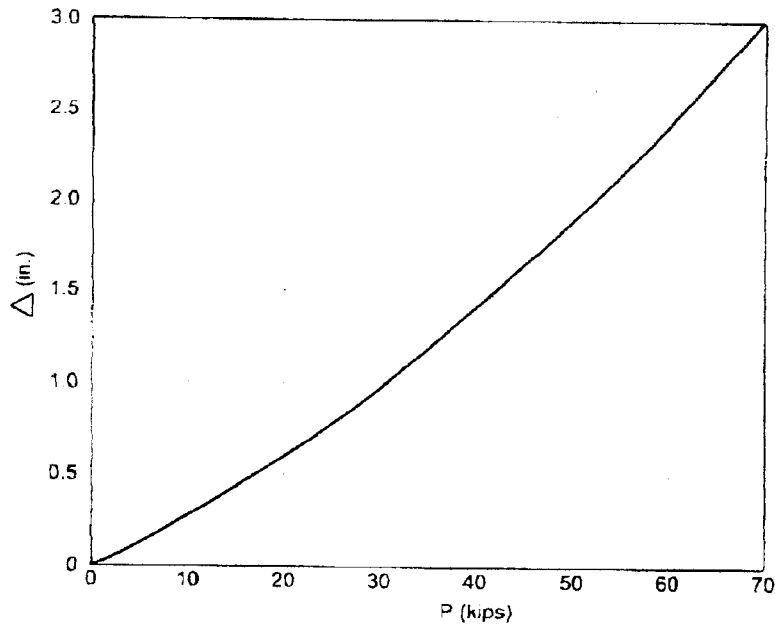
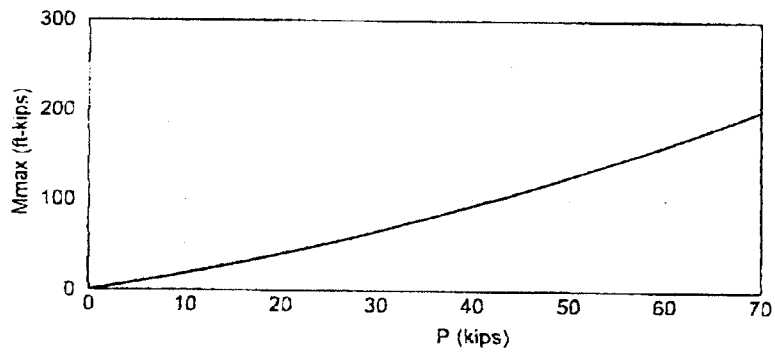
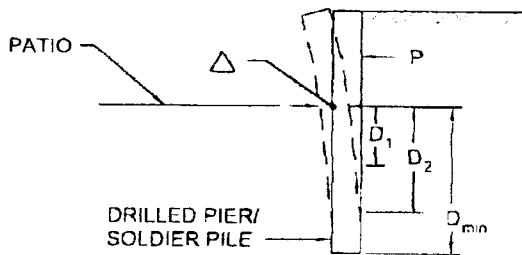
**DRILLED PIER
 LATERAL BEHAVIOR**
 Failed Retaining Wall at
 5712 Country Club Drive
 Oakland, California

- P = Total lateral load on wall
- Δ = Pier deflection at top of patio slab below wall
- Mmax = Maximum moment
- D₁ = Depth to Mmax (4 ft)
- D₂ = Depth to first zero deflection (7 ft)
- D_{min} = Minimum pier depth (9 ft)
