# WOOD DESTROYING PESTS AND ORGANISMS INSPECTION REPORT

BUILDING NO. 5734	STREET Country Club DR	CITY Oakland	ZIP 945618	COUNTY CODE 01	DATE OF INSPECTION 04/24/02	NUMBER OF PAGES 4
----------------------	---------------------------	-----------------	---------------	-------------------	--------------------------------	----------------------

**DRAPER TERMITE**  
1040 Vine Avenue  
Martinez, CA 94553  
(925) 228-6564

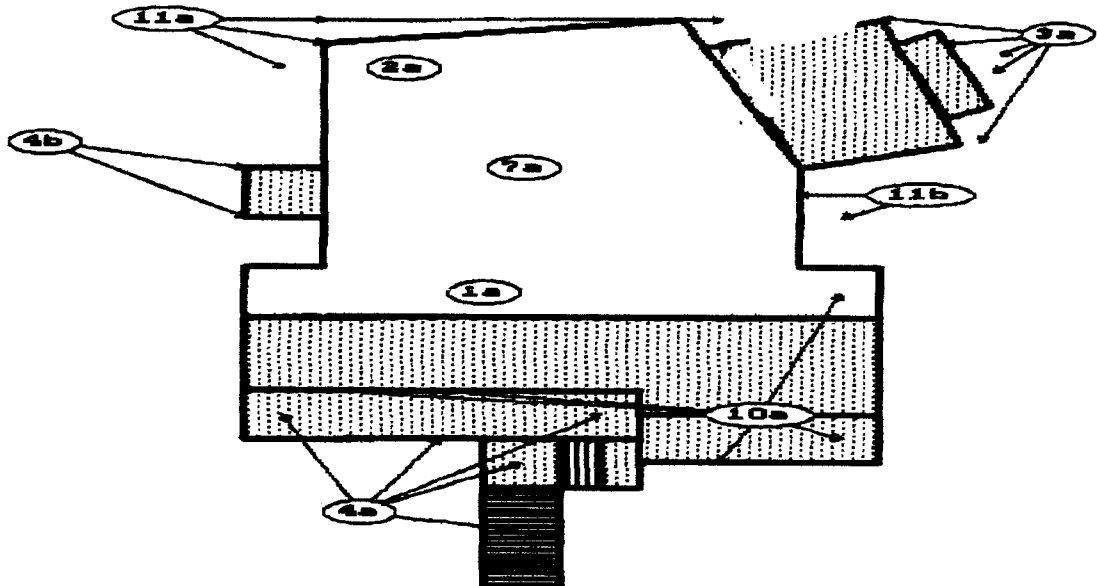
DIAGRAM AND EXPLANATION OF FINDINGS (This report is limited to structure or structures shown on diagram)

Item 1A: The subarea soil was found to be dry to wet at time of inspection. There is evidence of periodic standing water in the substructure area. A sub pump is installed in subarea improperly  
RECOMMENDATION: Reinstall sub pump and drain pipe properly

Item 2A: Water stains were noted to subflooring under master bath tile stall shower and closet floor. Flooring in closet was uneven.  
RECOMMENDATION: Remove part of flooring in this area for further inspect the sealed sub flooring and water test stall shower.  
\*\*\*\*\* Unknown Further Inspection Recommended \*\*\*\*\*

Item 3A: A faulty grade/earth to wood contact condition and fungus damage to mudseal was noted at these area of the structure.  
RECOMMENDATION: Reduce the grade level remove fungus damage for further inspection and correction of the faulty grade/earth to wood contact condition. Any additional findings will be listed on a supplemental report.  
\*\*\*\*\* This is a Section 1 Item \*\*\*\*\*

Item 4A: Fungus has damaged the wood framing beneath brick steps and porch as viewed from the subarea.  
RECOMMENDATION: Remove the brick and fungus damaged framing for further inspection. If no further damage is exposed, replace the damaged framing with new material. install new wood siding wood steps and hand rails install concrete porch. install new sheetrock ceiling in basement part that is under porch.  
\*\*\*\*\* This is a Section 1 Item \*\*\*\*\*

Item 4B: Fungus has damaged the framing beneath the concrete steps and porch at left side as viewed from the subarea.

Item 10A: Waterstains/water and damage were noted to the sheetrock and flooring adjacent to the windows and doors.

Item 11A: The wood soffit at the eaves of the structure is water stained and fungus damage in areas.

Item 11B: Fungus has damaged the window sashes at the structure.

RECOMMENDATION: Remove the concrete steps and porch remove fungus damage framing for further inspection. If no further damage is exposed, replace the damaged framing with new material. install new wood steps and porch.  
\*\*\*\*\* This is a Section 1 Item \*\*\*\*\*

RECOMMENDATION: Remove the stained/damaged sheetrock at windows and doors and below area in basment for further inspection.

RECOMMENDATION: Remove the fungus damage section of the eave soffit for further inspection. If no further damage is exposed, replace with new material. Prime paint only.

RECOMMENDATION: Remove the damaged sashes for further inspection. If no further damage is exposed, replace with new sashes. Prime paint only.

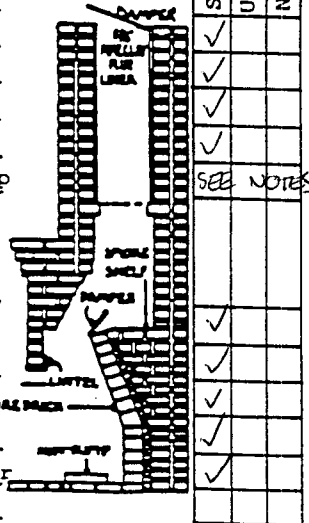
SYSTEM EVALUATION

EXTERIOR :- This is a 1/2 storey masonry chimney venting a wood-burning fireplace through a terra-cotta lined 13" x 18" flue. There is also an 8" sq. utility flue which is only lined for the top 2', which is currently venting the water heater + furnace. The chimney is approx 2' shorter than current codes call for (existing non-combusting condition). The cap is undersize. No seismic nor settling damage was noted; however a large

part of the column below the roof is obscured by vegetation + cannot be seen.

INTERIOR :- The firebox is in good condition, there is a working damper. Smoke-chamber is in adequate condition. Hearth + facing are in good condition - clearances to combustible are adequate. Chimney is dirty.

Exposed column + foundation at column in crawlspace are in good condition. Sub-hearth cannot be seen original wooden supports are still in place. Some efflorescence was noted at bottom of facing + hearth - probably water

RECOMMEND entering flue from top  
 ① Sweep chimney \$105 00  
 ② Modify existing spark-arrestor/raincap to meet current requirements + lessen water entry. \$50 00

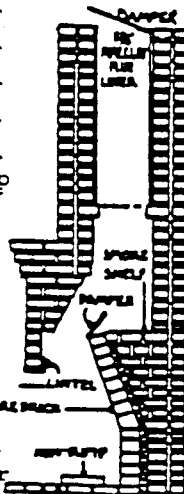
SYSTEM EVALUATION

EXTERIOR :- This is a 2 storey masonry chimney venting a wood-burning fireplace through a terra-cotta lined 13" x 15" flue. It is not fitted with an appropriate spark-arrestor/raincap. A minor settling crack has opened to bottom left of column outside house - no visible earthquake damage was noted. No movement was felt when moderate lateral pressure was applied at chimneytop. The adjacent tree should be cut back to the appropriate

6' from chimneytop. Outside ash dump door rusted shut.

INTERIOR :- The firebox is in good condition - some efflorescence was noted, but no loose bricks. Minor hairline crack was noted in lower back wall - no action necessary at this time. The large field-stone facing is in good condition - minor hairline settling crack to left of fireplace. The damper is stiff, but does open + close + will probably free-up with use. Hearth/firebox floor are fieldstone and are in good condition - some efflorescence + flaking of firebox floor due to water entering chimney. Inner ash dump door has broken frame.

- ① Supply/install compliant spark-arrestor/raincap. \$95 00
- ② Supply metal plate to cover hole in floor resulting from broken ash-dump frame \$35 00
- ③ Have adjacent tree cut back to recommended 6' from chimneytop (not work done by the Chelsea Co)
